# Measurement and Analysis of Walkability in Hong Kong

An Interactive Qualifying Project Report  
Submitted to the faculty of the  
Worcester Polytechnic Institute  
In partial fulfillment of the requirements for  
Degree of Bachelor of Science  
In cooperation with Designing Kong Hong, Ltd. and  
The Harbour Business Forum  
On March 4, 2010

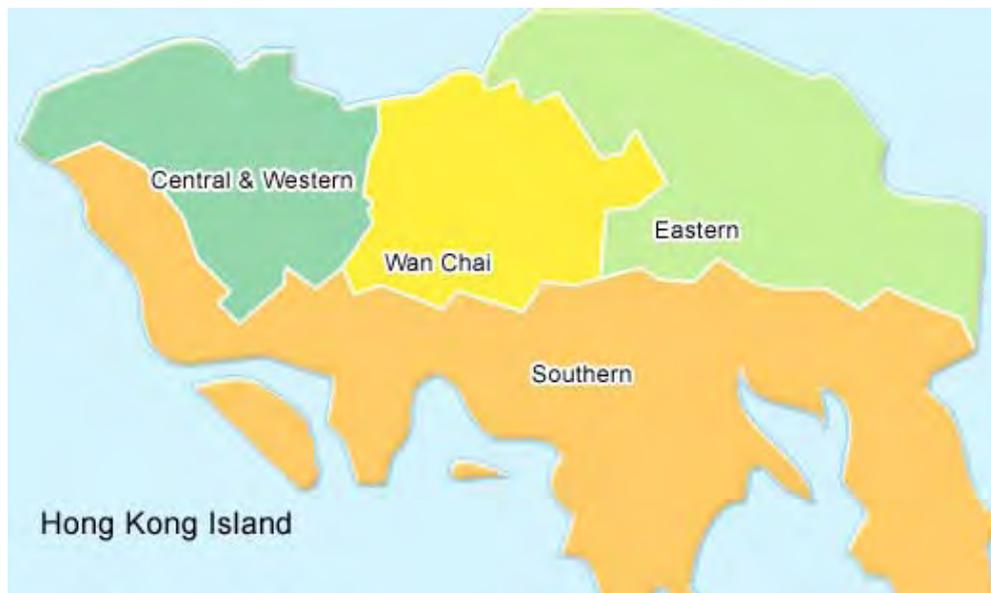
Figure 2.4-2: Districts of Hong Kong Island (Home Affairs Department, 2010)

Hong Kong Island is located south of Victoria Harbour. There are four districts of Hong Kong Island: Central and Western, Eastern, Wan Chai and Southern (Home Affairs Department, 2010). Central and Western, Eastern, and Wan Chai, will be the main focus of this report. Figure 2.4-2 highlights the boundaries of each district.

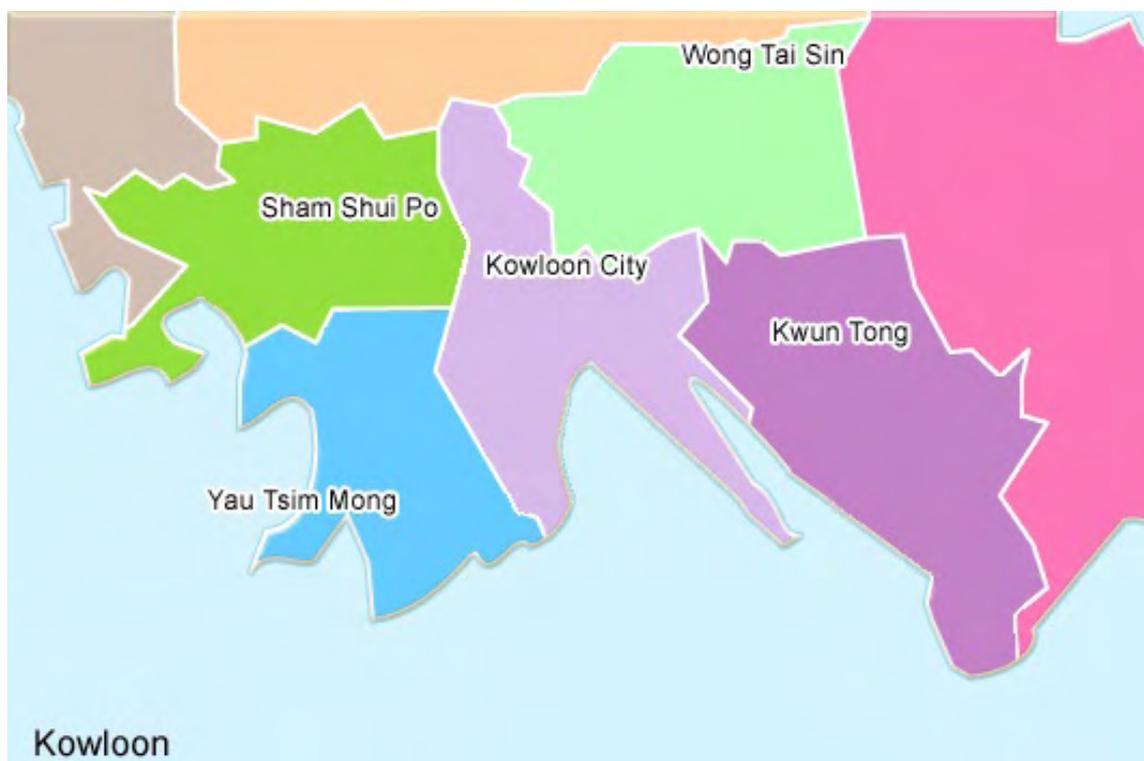
Figure 2.4-3: Map of Kowloon Administrative Districts

The Central and Western, Wan Chai, and Eastern District all run along Victoria Harbour. To the north of Victoria Harbour is Kowloon. Kowloon is comprised of fourteen action areas. Our team found it useful to cluster these action areas into the five administrative districts shown in Figure 2.4-3.

The Kwun Tong administrative district is comprised of four districts, Lei Yue Mun, To Kwa Wan, Yau Tong and Yau Tong Bay. Kwun Tong is one of the largest administrative districts in Hong Kong, housing more than eight percent of Hong Kong's population within its 1,130 hectares (Home Affairs Department, 2010). The district contains industrial, business, and residential sections and many new redevelopment projects are in progress. Recently, Kwun Tong has focused its efforts on the Lei Yue Mun Waterfront Enhancement Project. This project aims to provide "a public landing facility, a breakwater and a waterfront promenade" to enhance the attractiveness of the waterfront and draw in more visitors (Tourism Commission, 2010, Lei Yue Mun Waterfront Enhancement Project).

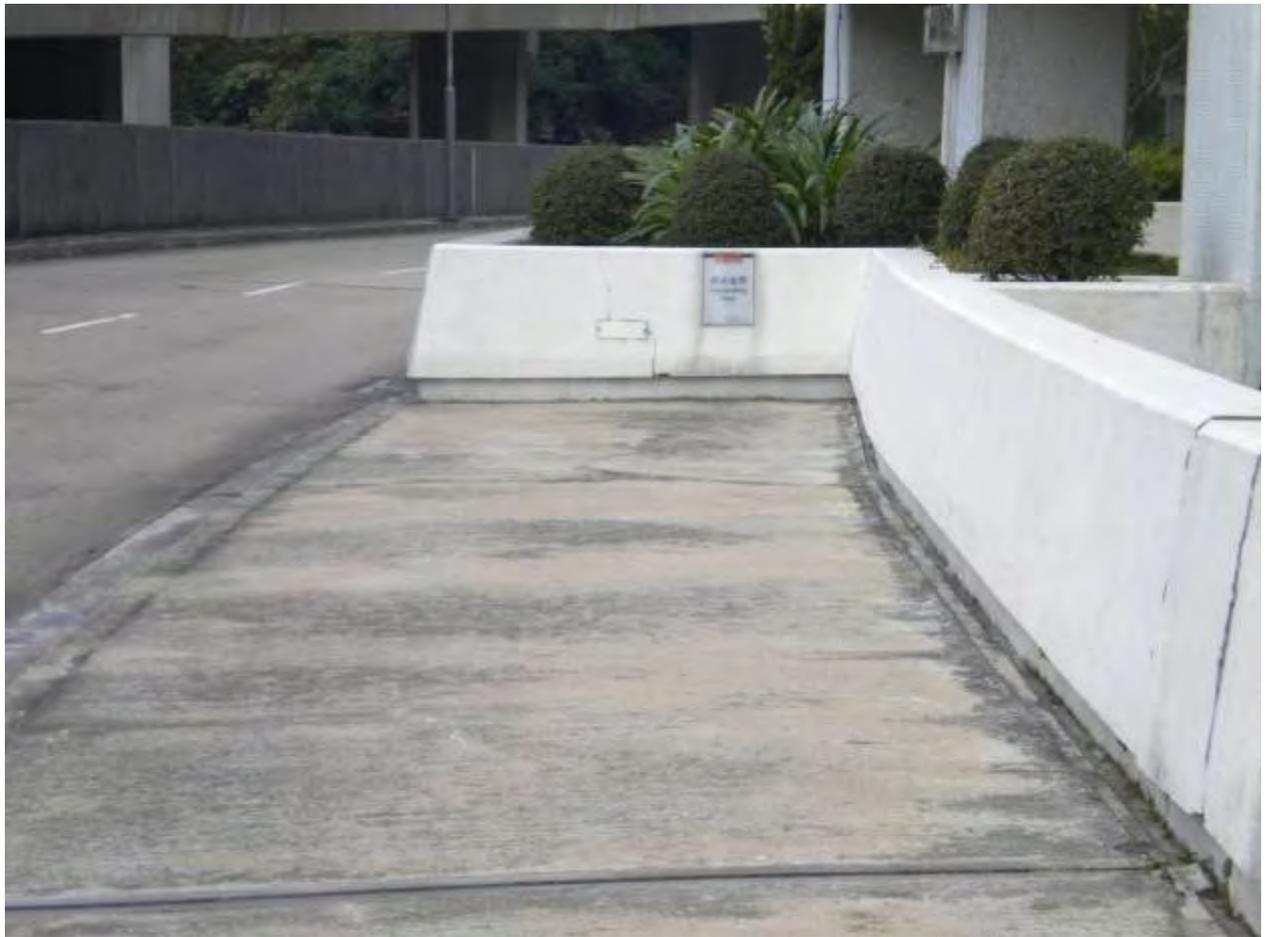
Figure 3.1-5 – Breakdown

A *breakdown*, shown in Figure 3.1-5 is defined as a barrier on a path that completely obstructs a pedestrian route and forces the pedestrian to turn around and go back the way they came. A breakdown is when a street or sidewalk abruptly ends or when there is construction that blocks the path a pedestrian would like to take. A breakdown is not the end of a park or enclosure of a sitting area.

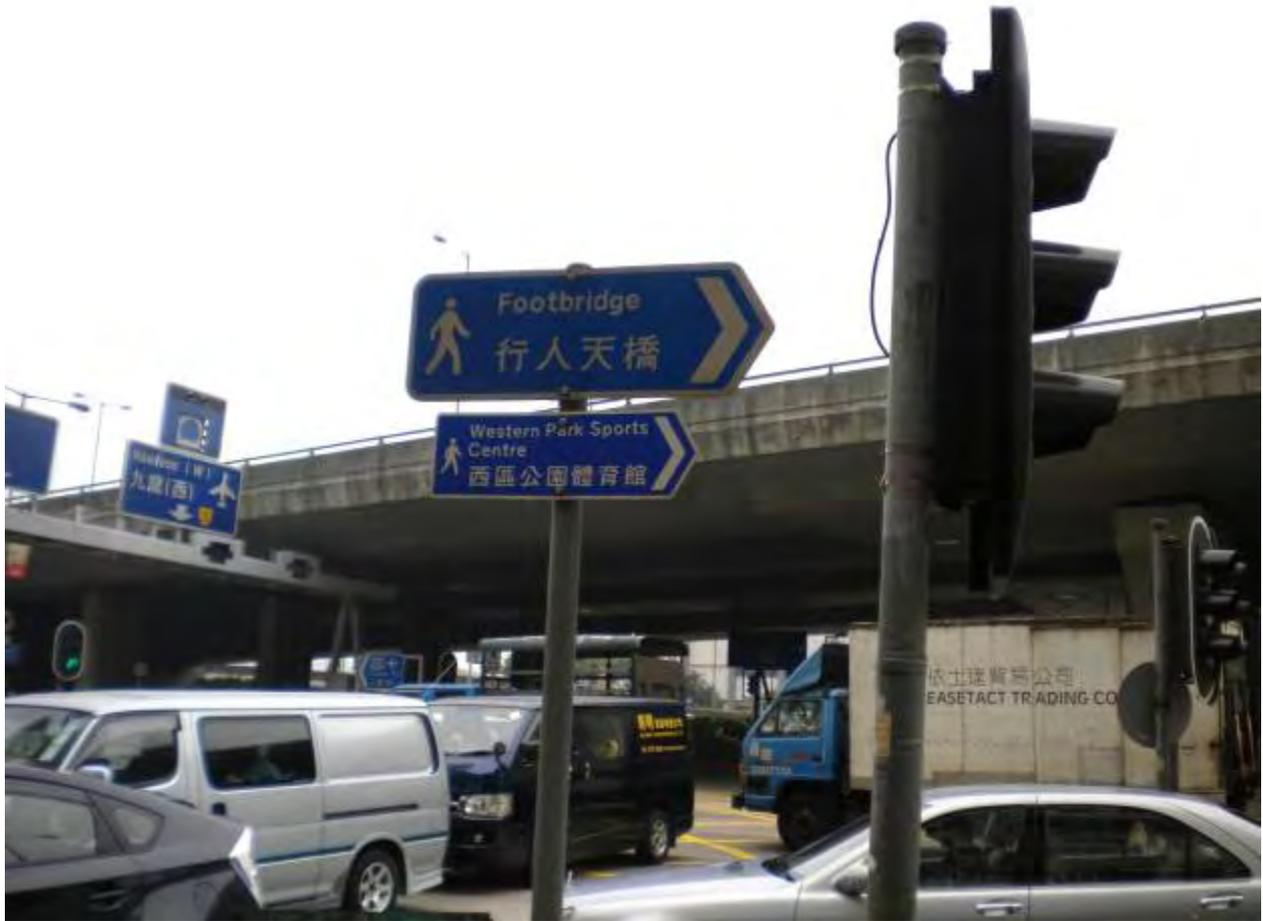
Figure 3.1-6 - Directional Sign

A *directional sign*, shown in Figure 3.1-6, has a directional arrow, is written in both English and Chinese, and is targeted towards pedestrians. A directional sign is also a map or any commercial sign that would help walkers find a destination such as a restaurant or shopping area. For the purpose of the preliminary evaluation, this excluded street signs showing the direction of the street. A directional sign is not one that is meant for vehicular traffic or other commercial forms of traffic, such as signs pointing to parking garages.

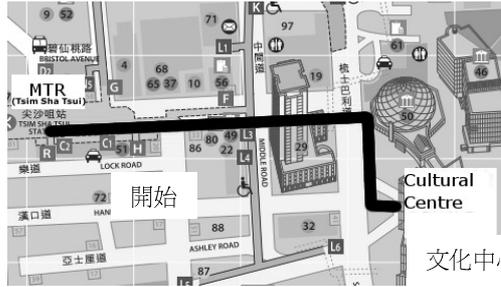
New zebra crossing on Salisbury Rd. in front of The Peninsula Hotel  
橫過半島酒店前新的行人過路處

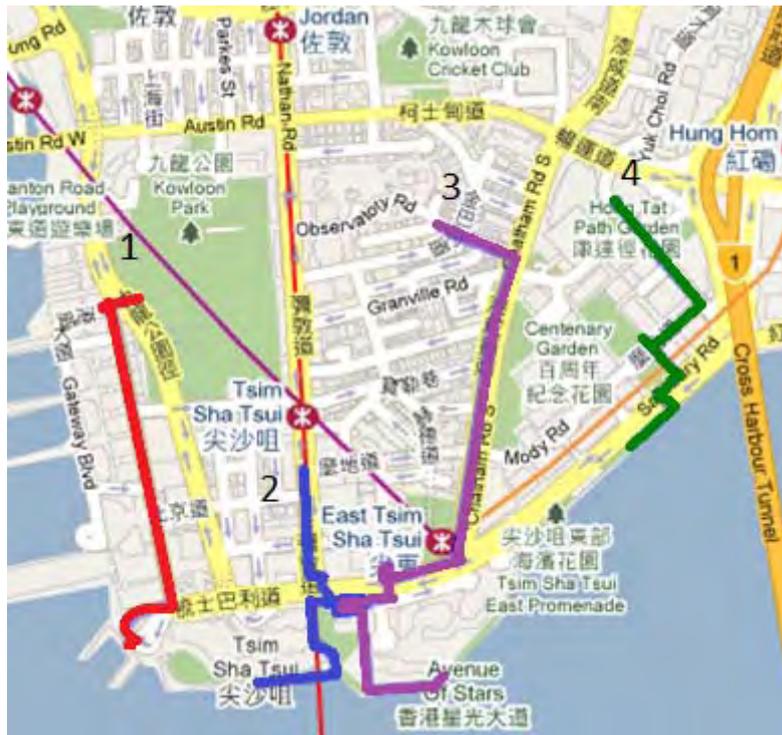
Figure 3.3 - 3 - Routes in Tsim Sha Tsui

for improvement. The team decided to test the rubric on 16 routes, four routes per final district. These four routes were approximately evenly spaced throughout the district with the ideal routes leading from main transit stations, large recreational areas, or residential blocks to the different areas along the harbor front. The following four maps (Figures 3.3-2 to 3.3-5) show the final districts, Wan Chai, Sai Ying Pun, Yau Ma Tei and Tsim Sha Tsui, and the four routes taken, noted in various colors, in each district.

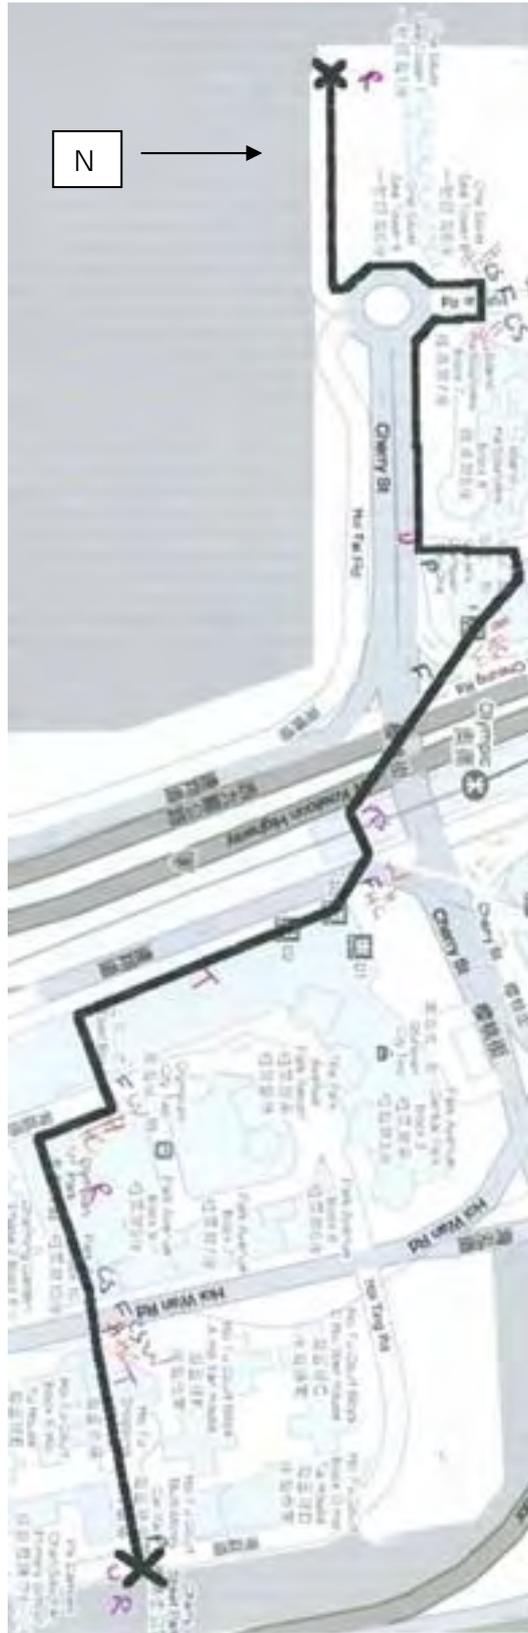
Figure 3.3-1- - Walking Map of Yau Ma Tei

Five colors and 15 letter codes indicated different types of criteria and made the maps easier to read for later reference. For example, whenever the team crossed a footbridge connection, a blue line was drawn on the map with the letter F next to it. Also written in blue was CS (connection sign) if the footbridge was missing a connection sign. As seen in the map in Figure 3.3-1, other connections and amenities were noted on the map as well. Additionally, team members noted and commented on areas under construction, confusing pathways, or any other

characteristics that they encountered while walking each route. Adjustments to the route from the pre-determined path were noted on the map as well. Each walking map is a visual of the connectivity, convenience and amenities of the route. The purpose of the walking maps was to provide visuals for the team to use when creating recommendation plans for each route. Due to the time constraints of this study, the team did not have enough time to re-walk each route to verify the focus areas of the WAT. The maps gave a very simple visual of where problems occurred and where small changes can be implemented to improve walkability in Hong Kong. The results chapter shows and discusses all of the maps in further detail.

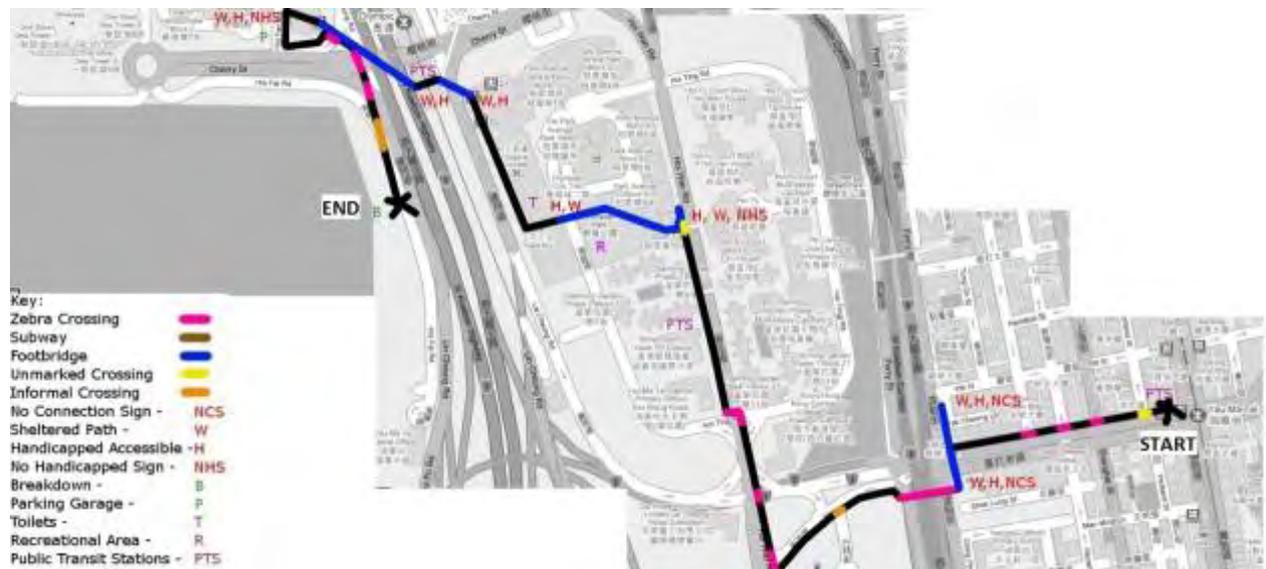
Figure 4.4-3 Route 3 Yau Ma Tei MTR Station to Yau Ma Tei Typhoon Shelter Walking Map

At 1.44 miles, this route (shown in Figure 4.4-3) is by far the longest route walked in the in-depth study. It starts at the Yau Ma Tei MTR exit B2 and continues down Waterloo Rd. to Ferry St., where it crosses the footbridge to the other side of Waterloo Road and crosses Ferry Street via a very long, segmented zebra crossing. Under the West Kowloon Corridor, many homeless people's piles of belongings can be seen and the area is very dirty. The route then continues to Hoi Wan Rd. where it heads north across several zebra crossings. This area is mainly residential and commercial. The team climbed up a footbridge to Olympic Park, a small but enjoyable park with seating and a playground located on the roof of the Park Avenue Housing Blocks. The route then leads through the Olympic City II mall where there are shops and restaurants before entering the Olympic MTR Station through exit D3. From there, the route led out of the mall, across a footbridge, and into the station briefly before exiting through exit E, which leads across a footbridge to Olympic City I. The route then exits the mall and takes a left onto Cherry St.

The Yau Ma Tei Route 3 table suggests that, most importantly, this route needs to be more direct and that the breakdown and informal crossing at the end of the route need to be addressed. Most of the pedestrian experiences also need improvement. Overall, this route needs improvement in all areas of the rubric.

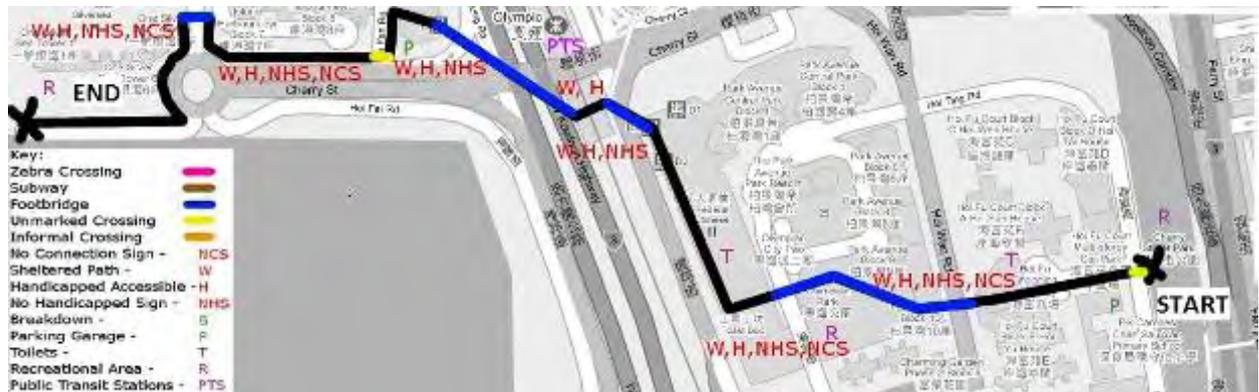
Figure 4.4-4 Route 4 Cherry Street Park to Silversea Promenade Walking Map

The route (shown in Figure 4.4-4) led from Hoi Fu Estates, a housing complex in the southern section of Yau Ma Tei, through the Hoi Fu Shopping Centre and across the footbridge to Olympic Park. It then leads through the Olympic City II mall where there are shops and restaurants before entering the Olympic MTR Station through exit D3. From there, the route led out of the mall across a footbridge and into the station briefly before exiting through exit E, which leads across a footbridge to Olympic City I. The team then exited the mall and took a right onto Cherry Street where they crossed a footbridge and followed the sidewalk around the rotary. The sidewalk leads to a beautiful but short promenade that is connected to the Long Beach promenade during the day. This route was either inside or covered for the majority of the route.

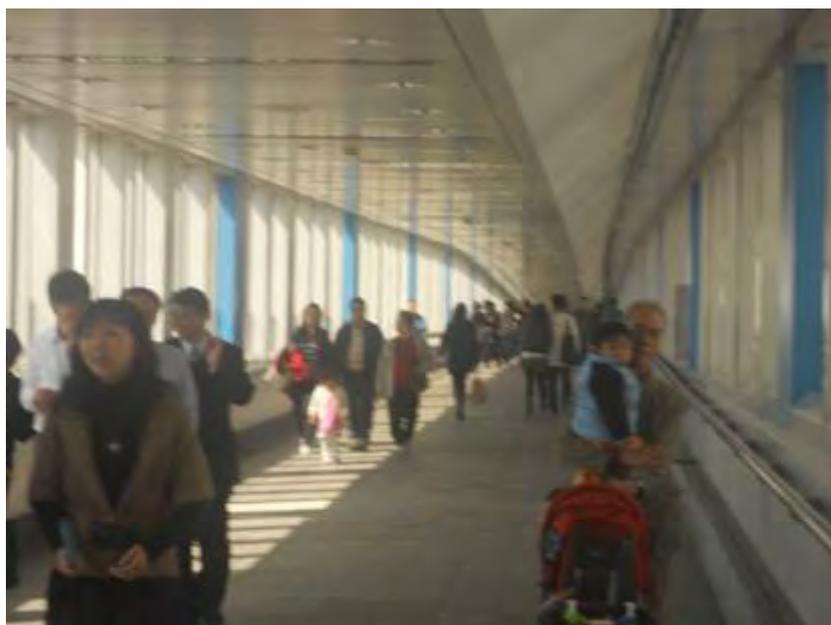
Overall, this district has few direct routes to the waterfront and needs more accessible, developed waterfronts. In addition, signage is needed for everything except public transit stations. The picture below (Figure 4.4-5) shows the pedestrian congestion at lunchtime, around 1:00pm. This picture was taken in the MTR Exit E footbridge that connects Olympic Station to Olympic City I. As three of the four routes pass through this footbridge, it is the main connection between the harbor front and the hinterland in Yau Ma Tei. The congestion at lunchtime is high because this is one of the few connections, forcing people to use it rather than spread out.

Figure 4.4-5 - MTR Exit E Footbridge in Yau Ma Tei

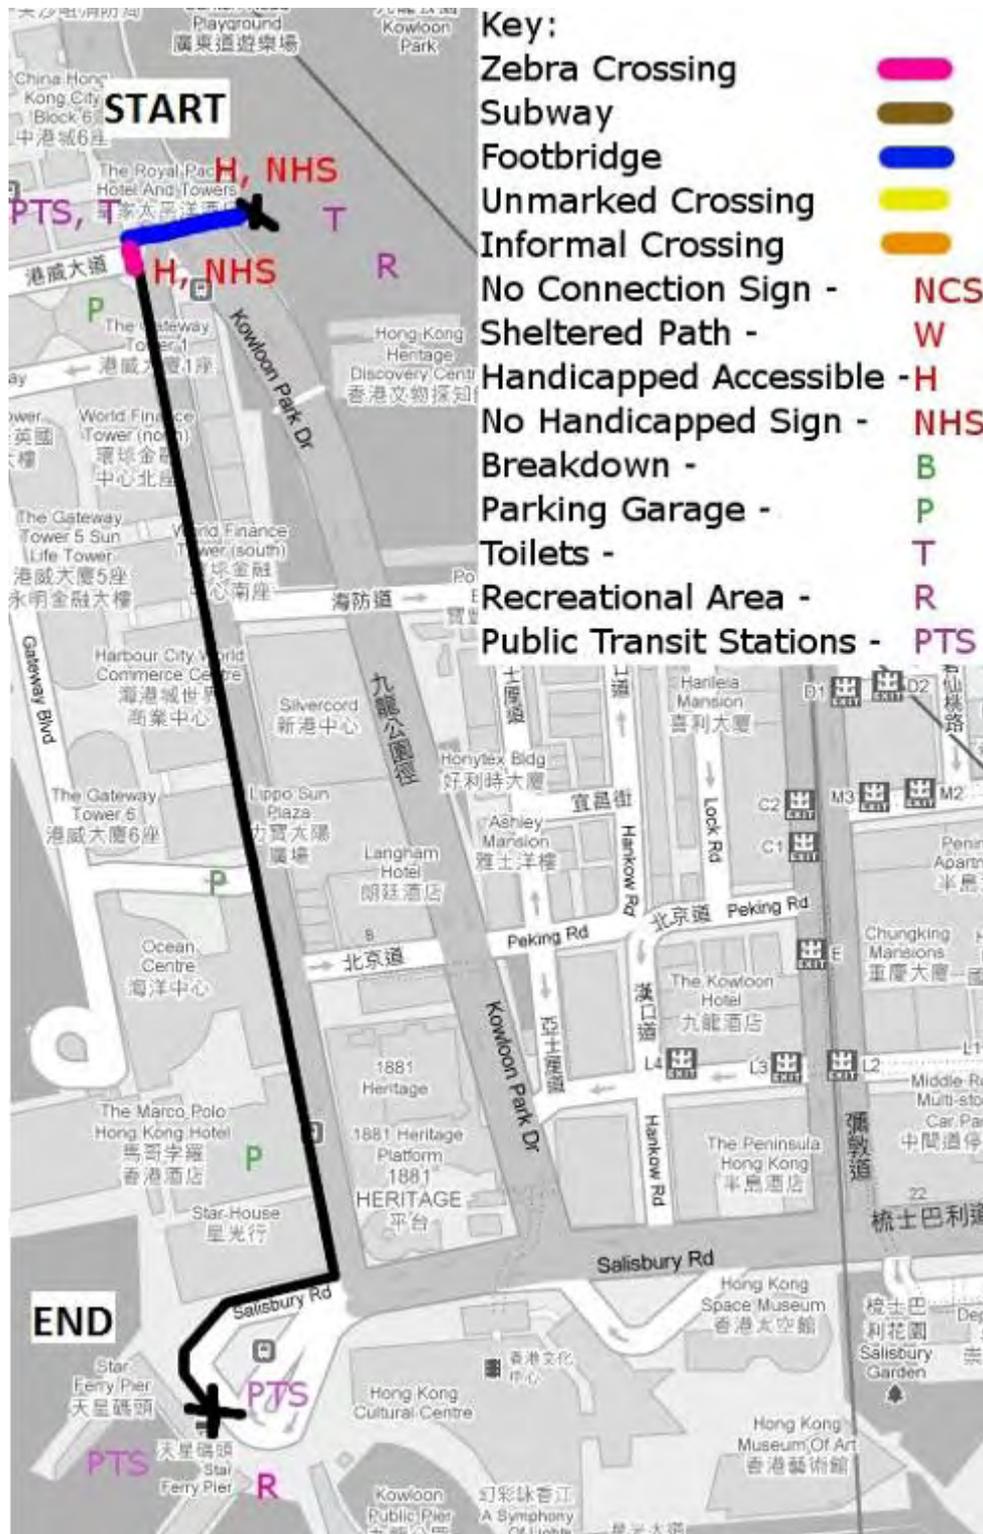
Figure 4.4-6 Route 1 Kowloon Park to Star Ferry Pier Walking Map

This route (shown in Figure 4.4-6) exits Kowloon Park near the flamingos and crosses an uncovered footbridge to the top of the Royal Pacific Hotel building. The path then leads down through the mall and the China Ferry Terminal to the street. This mall has shopping and food within as well as several transportation hubs located close by. After exiting the building, the route continues south on Canton Rd. past many dangerous entrances to construction sites and parking garages. Many of these entrances have guards to stop people from crossing. The view on Canton Road is very pleasing, with high end shops lining the street; however, the sidewalk is often crowded and the vehicles are loud. At the end of Canton Road the route leads right along the sidewalk to the Star Ferry Pier. The Star Ferry Pier is flanked by two stretches of waterfront, one in front of the Ocean Centre and the other in front of the Hong Kong Cultural Centre and the Clock Tower.

The Tsim Sha Tsui Route 1 table suggests that the route has too many parking garages and the promenade needs seating. The footbridge needs signs that it is handicapped accessible and a cover to protect it from the weather. With the exception of these issues, the route was aesthetically pleasing and direct with excellent signage.

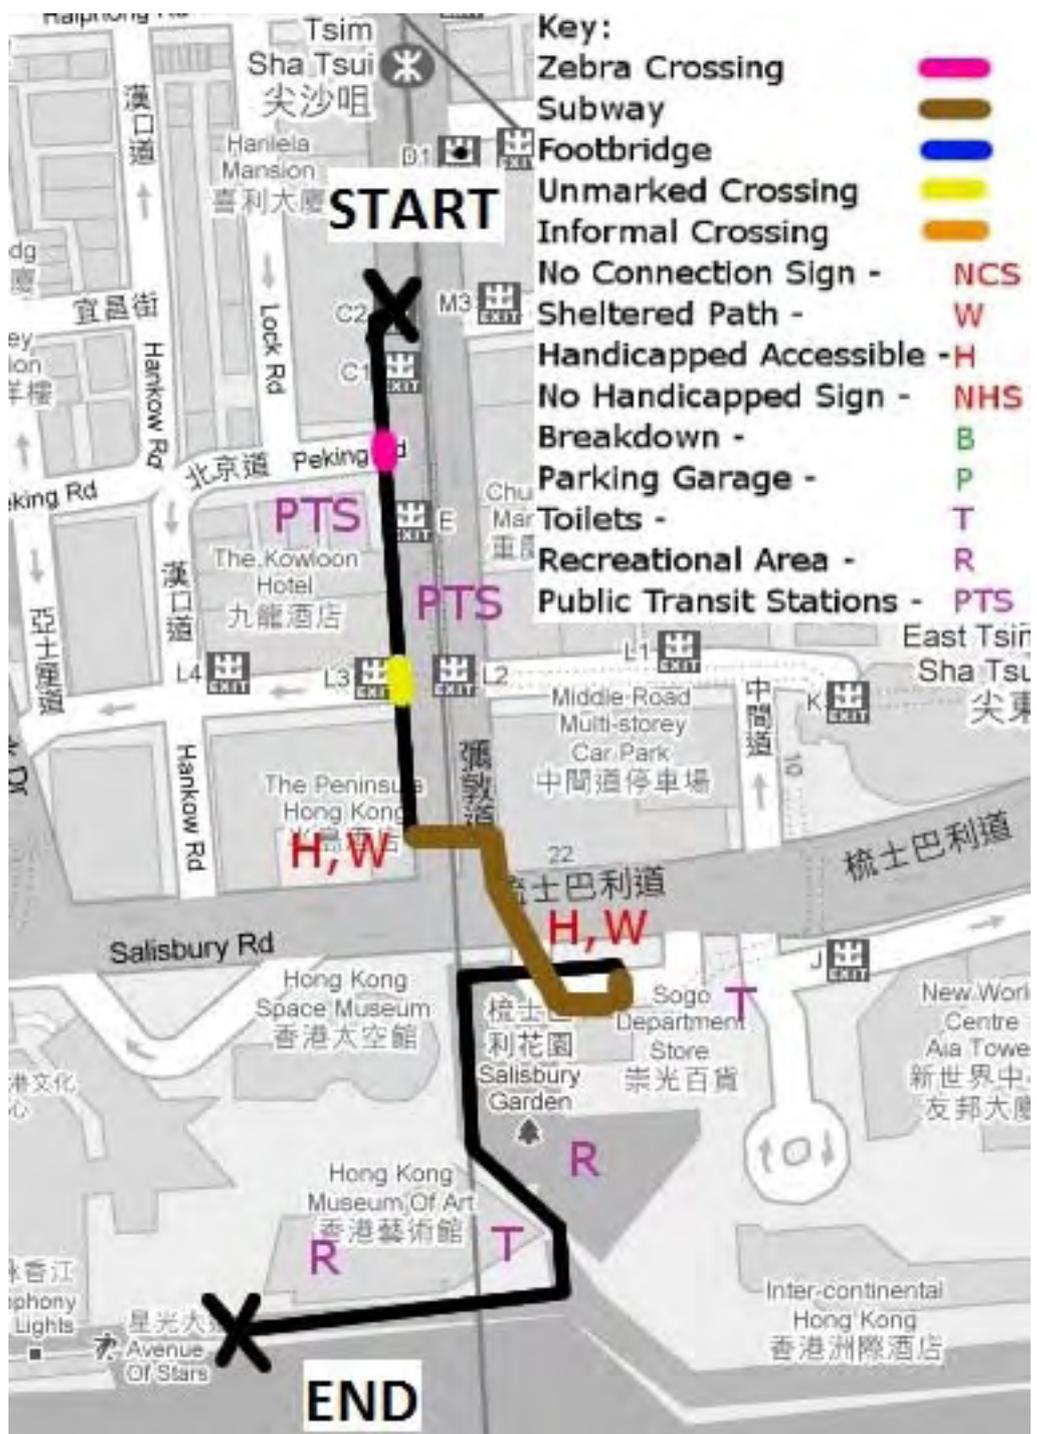
Figure 4.4-7 Route 2 Tsim Sha Tsui MTR exit C2 to Symphony of Lights Waterfront Walking Map

This route (shown in Figure 4.4-7) leads south down Nathan Road towards the harbor. Both the pedestrian and vehicular traffic on Nathan Road is very loud and busy. Next to the Peninsula Hotel, the route leads down a subway into the SOGO

The Tsim Sha Tsui Route 2 table suggests that the quality of the route and the visual aesthetics need to be improved. The number of seating areas and the unmarked crossings could also be improved. Overall, the route had excellent signage and was completely handicapped accessible.

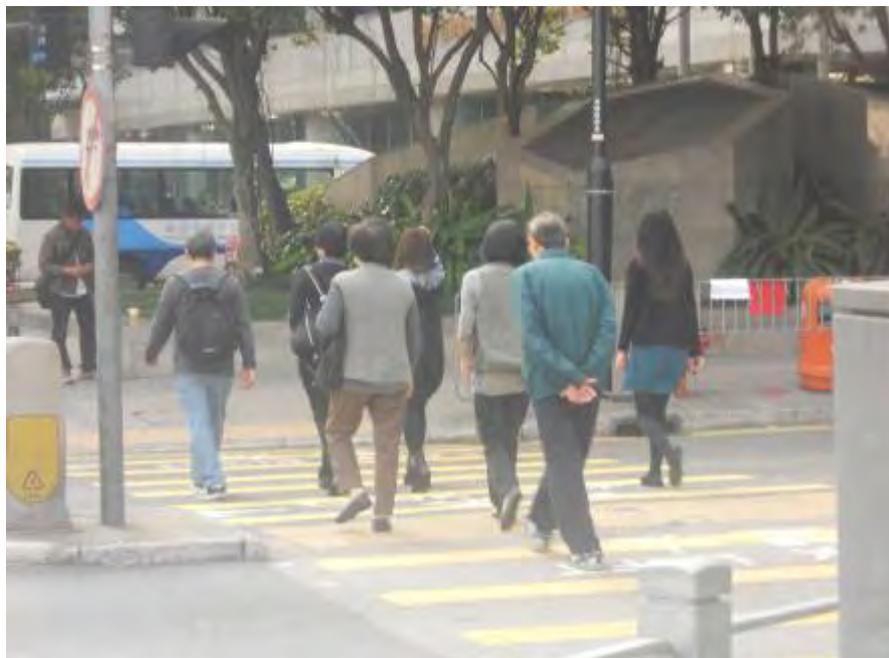
Overall, this district has too many modal conflicts such as parking garages and unmarked or informal connections. In addition, the quality of the route generally needs to be improved because of the multitude of construction sites. The picture below (Figure 4.4-15) shows the pedestrian congestion at lunchtime, around 1:00pm. This picture was taken at the zebra crossing across Convention Avenue near the Hong Kong Convention and Expo Centre. As this crossing is on the route from the MTR to the Expo Centre promenade, it is one of the main connections between the harbor front and the hinterland in Wan Chai. The congestion at lunchtime is moderate because, though this is a very high traffic area, many tourists arrive to the Expo Centre via tour bus while locals can arrive via the Star Ferry.

**4.4-15 - Zebra Crossing at Convention Ave near the Expo Centre**

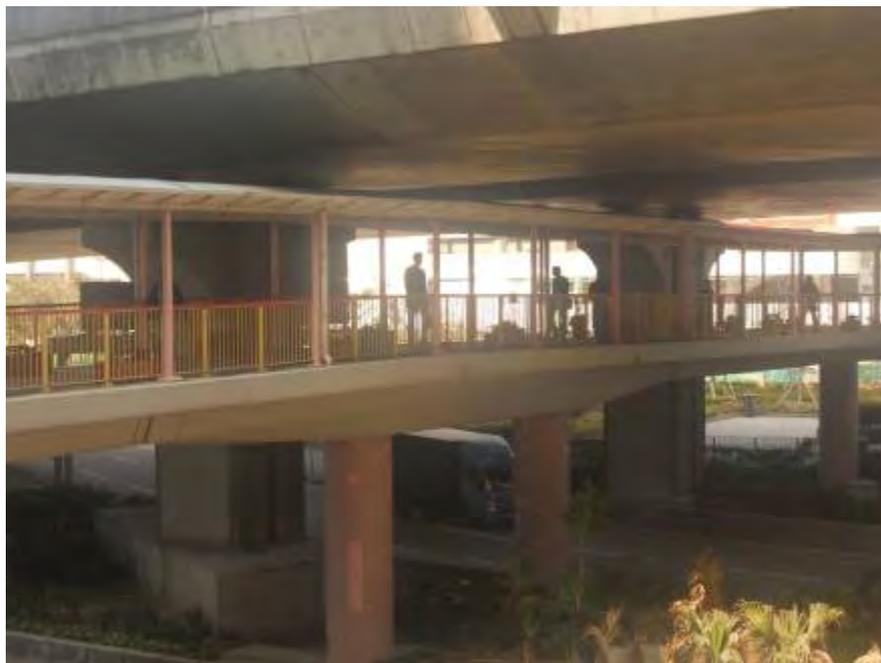
the pedestrian congestion at lunchtime, around 1:00pm. This picture was taken at the footbridge leading to Sun Yat Sin Park. As this park is the main waterfront promenade in the district, it is one of the main connections between the harbor front and the hinterland in Sai Ying Pun. The congestion at lunchtime is low because this is a low traffic district in which fewer people seem to visit the waterfront.

**Figure 4.4-20 - Footbridge to Sun Yat Sin Park in Sai Ying Pun**

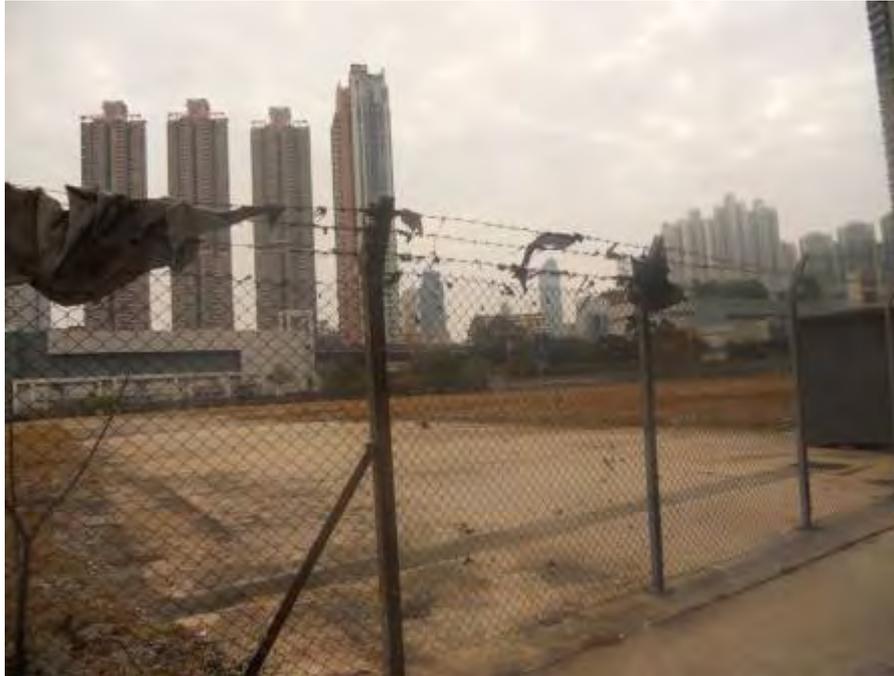
Figure 5.1-1 Empty Lot near Waterfront in Yau Ma Tei

This route ended in a breakdown in front of the Marine Police Operational Base. There was nowhere to reach the waterfront within 100 m. A solution is to extend the promenade in front of the Long Beach north to in front of Hampton Place and create another access point to the waterfront on the northern side of Hampton Place. To reach this access point from the other side of the street, a connection is needed. Because this is a low traffic street, a street-level connection such as a zebra or at least an unmarked crossing is sufficient. This promenade needs seating areas and nice landscaping to mesh with the Long Beach promenade. The general attractiveness and aesthetics of the route also needs to be improved as there are several empty lots and parking lots. More trees or planters should be placed along the sidewalk and the empty lots should either be developed or cleaned up.

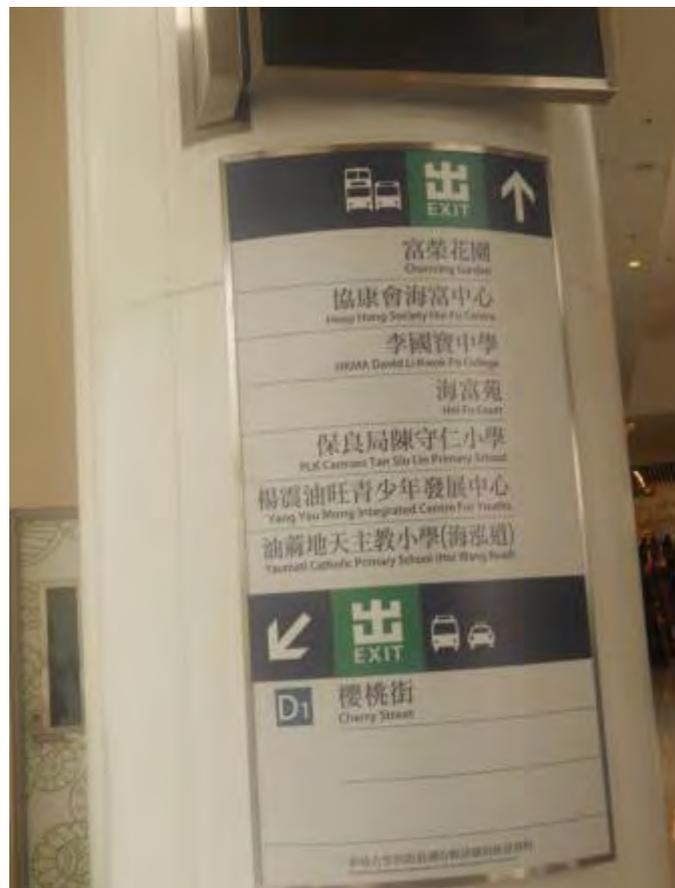
Figure 5.1-2 MTR Exit D1 Sign

The main issue with this route is signage. The footbridges over Tong Mi Road and Hoi Fan Road both need signs for their location and to indicate whether they are handicapped or not. The D1 Exit from the MTR station is not handicapped accessible but there is another route through Olympian City II that is handicapped accessible. However, this route is not labeled nor is it indicated that Exit D1 is not handicapped accessible. It is simple for either the MTR or Olympian City to post a sign for the elevator near the exit from the MTR Exit D footbridge.

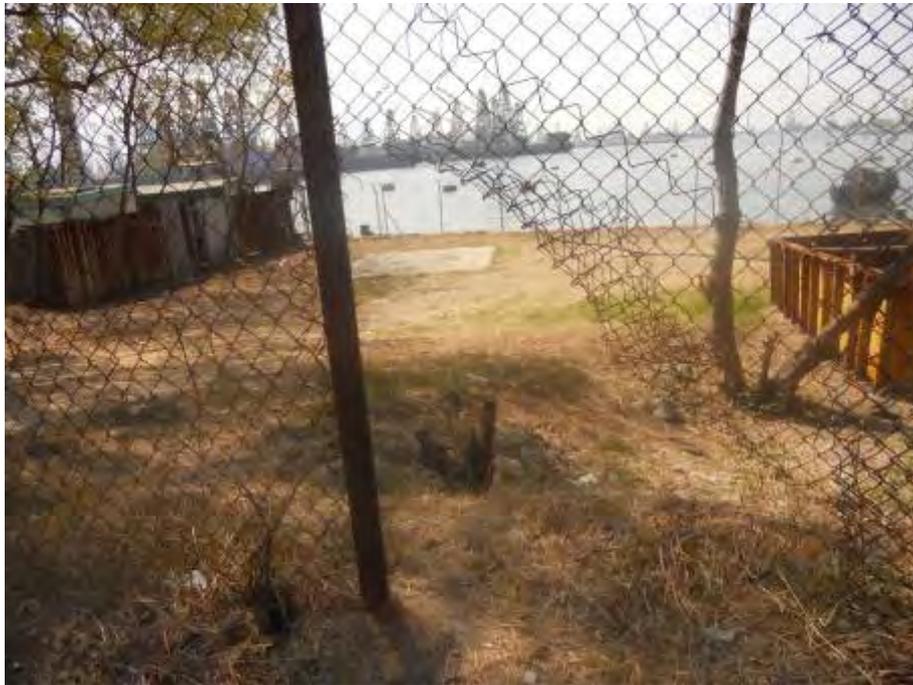
**Figure 5.1-3 Hole in Fence for Waterfront Access**

solution to this lack of waterfront is to simply cut through a hole in the fence, pictured below in Figure 5.1-3.

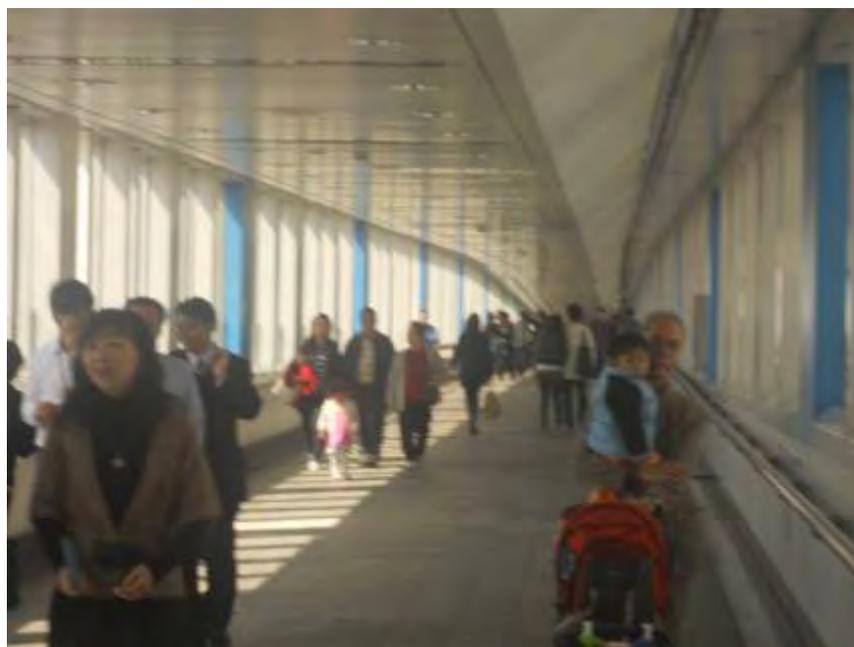
Figure 5.1-4 MTR Exit E Footbridge

that it is handicapped accessible. The MTR Exit E footbridge on the inside of the mall needs a sign indicating that it is handicap accessible. The footbridge across Hoi Fai Road needs signs on both ends showing the location of the footbridge and indicating that it is handicap accessible. In addition, there are no signs for the harbor front anywhere along the route. A suggestion is to place one inside the Olympian City I mall and another just outside the exit pointing towards the Silversea Promenade.

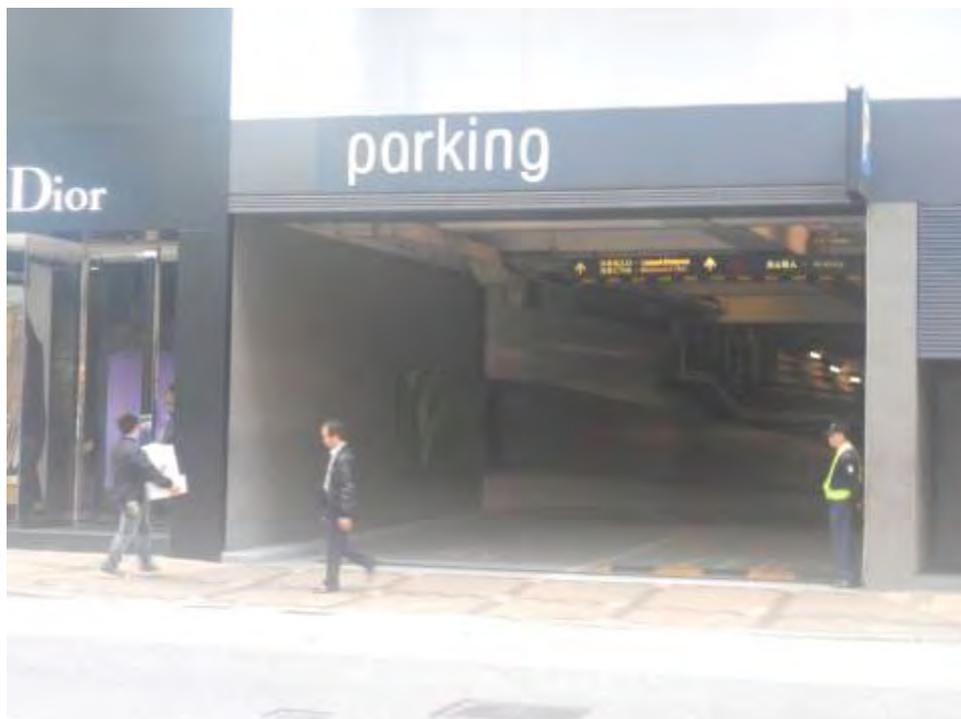
thereby restricting pedestrian flow. However, the main issue is the parking garages (see Figure 5.1-5). The parking garages are modal conflict areas; this is dangerous to both pedestrians and vehicles. The parking garages have guards directing traffic because Tsim Sha Tsui is a high traffic area. This increases the safety of these garages, but the pedestrian traffic flow is significantly diminished. To increase both the safety and traffic flow rate of pedestrians and vehicles, a separate connection should be placed along Canton Road. Canton Road is lined with upscale shopping centers so the installation of a subway would detract from the shopping experience. However, if a footbridge was installed, every shop would need a second floor access point. There is not an easy solution for this problem, yet this needs to be addressed. The recommendation proposed is to use Gateway Boulevard as an access road for the parking garages, therefore removing the entrances on Canton Road. This would significantly improve the pedestrian flow and the safety along Canton Road, a famous shopping area.

Figure 5.1-5 Parking Garage on Canton Road

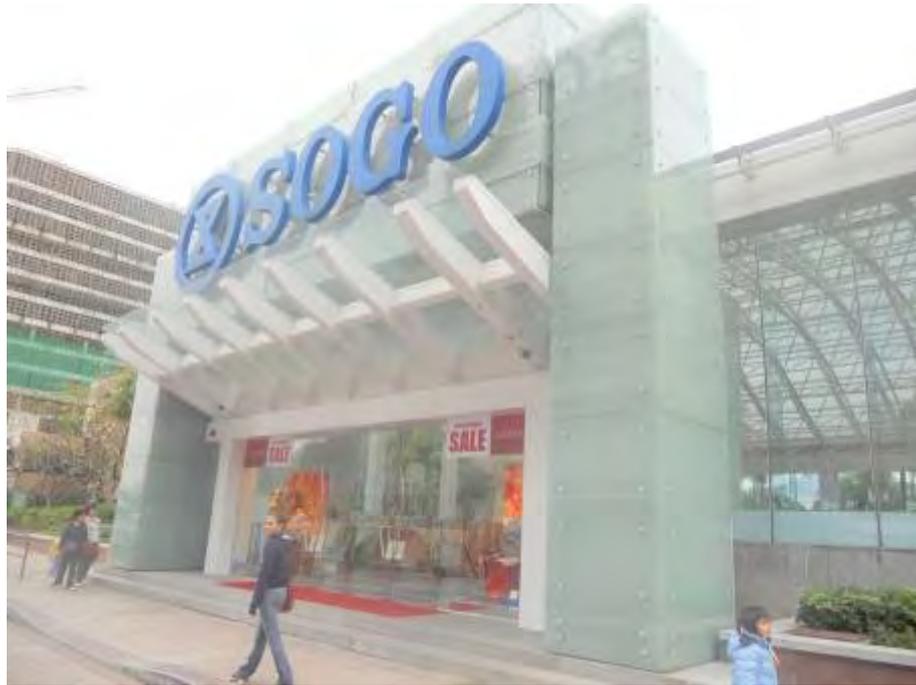
Figure 5.1-6 Entrance to SOGO Underground Mall

Pedestrians can see their destination and are allowed to walk straight to it. This would greatly increase the pedestrian flow rates for minimal costs; however, doing so would disrupt vehicular traffic flow and place priority on pedestrian flow. The quality of this route needs to be addressed because it is a highly traveled path that involves too much confusion.

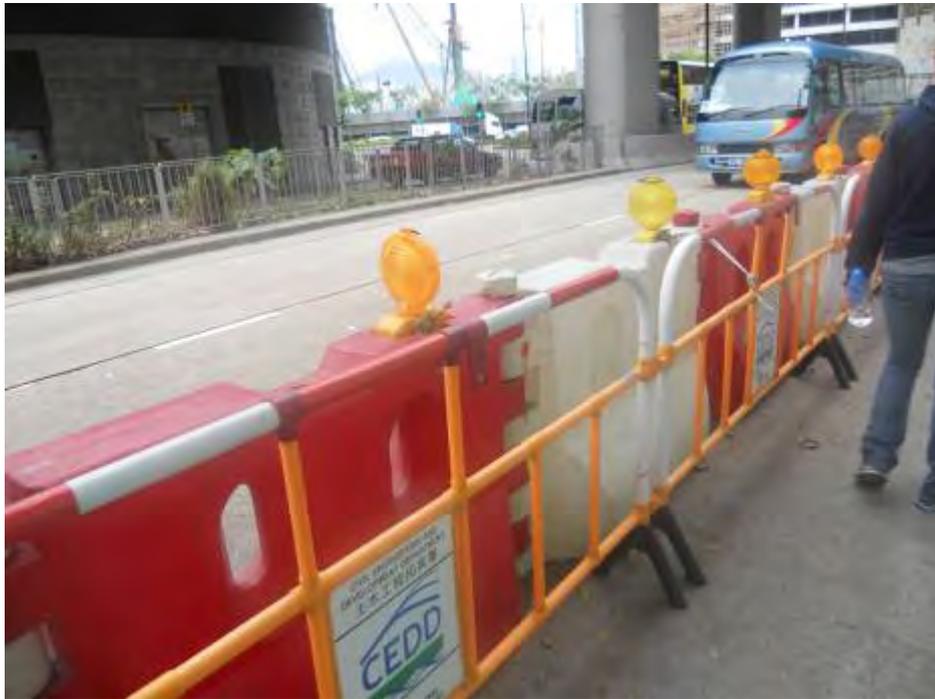
Figure 5.1-7 Construction Detour on Chatham Road South

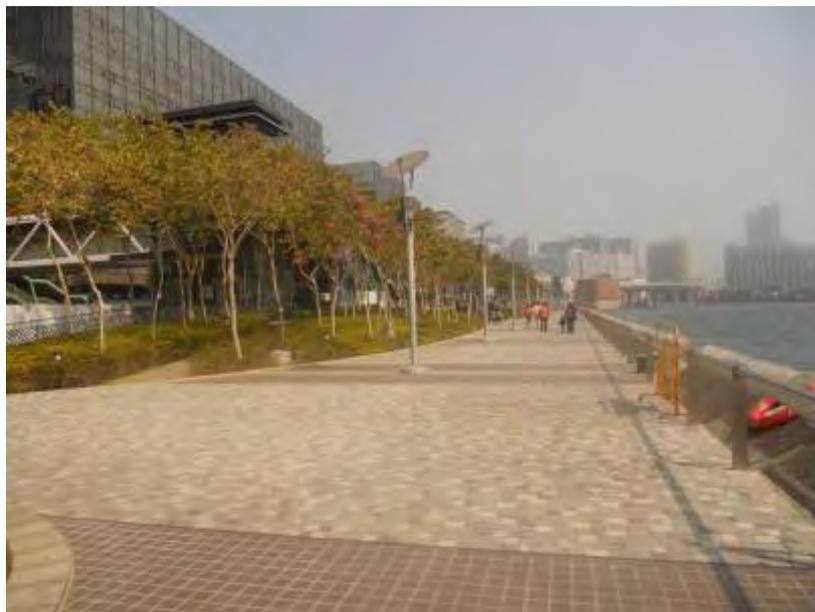
Figure 5.1-8 East Tsim Sha Tsui Promenade and Seating Area Under Trees

elements. The unmarked connection on the map needs to be addressed because there is too much vehicular traffic for good pedestrian flow and safety. The construction along the path must be checked to make sure that it is safe for pedestrians to walk alongside. There is not enough seating along the route, specifically at the end. The Tsim Sha Tsui promenade is one of the best in Hong Kong and is popular all times of the day; therefore, it needs more seating on the east Tsim Sha Tsui side where this route ends. The seating at the East Tsim Sha Tsui Promenade, Figure 5.1-8, has to be extended further along the promenade. Because of the number of people traveling this route, there needs to be at least one if not two toilets installed along the route. An improvement to these aspects will improve the pedestrian convenience and comfort, which will inevitably increase the number of people who walk this already popular route.

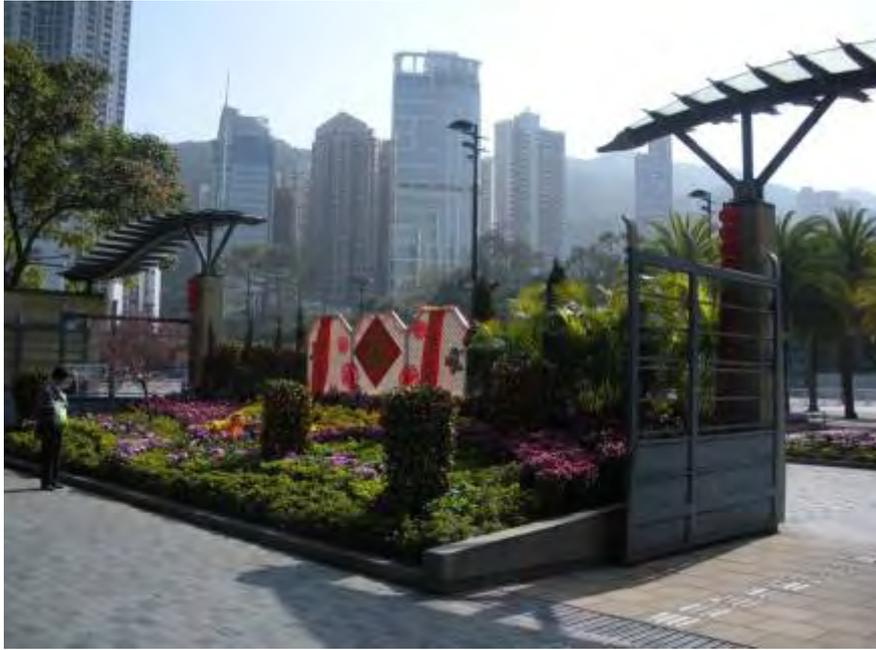
Figure 5.1-9 - Victoria Park Entrance

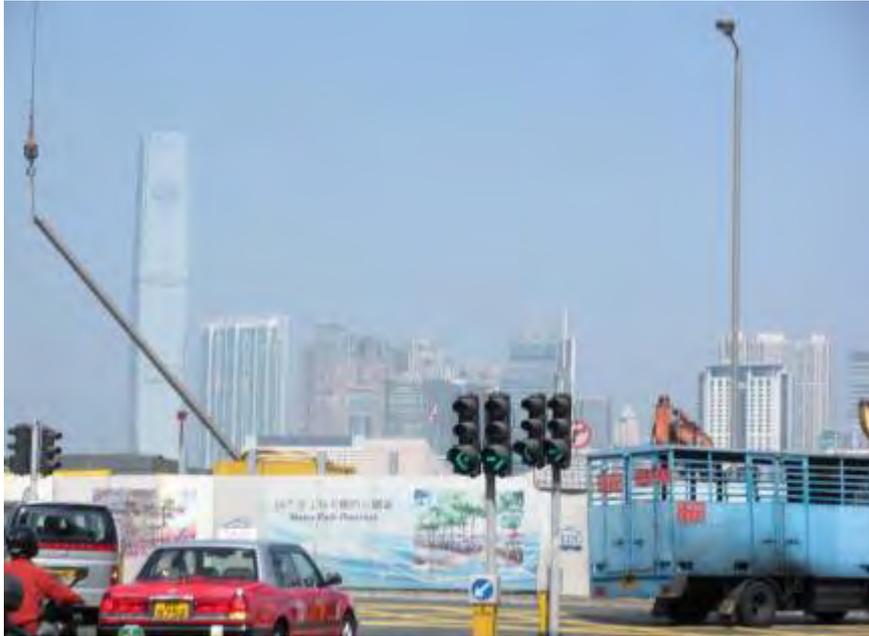
Figure 5.1-10 - Construction Breakdown Point in Wan Chai

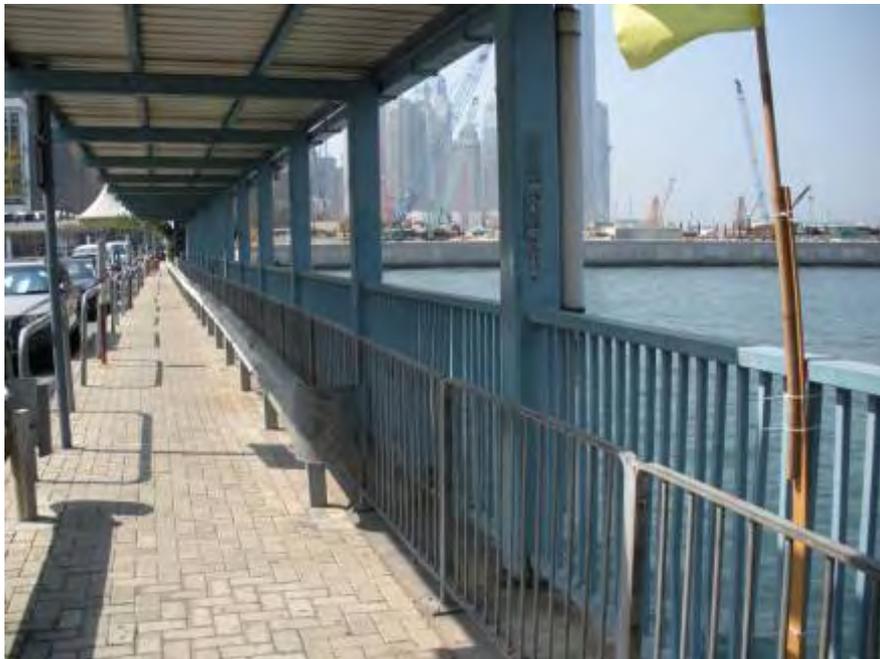
Figure 5.1-12 - Waterfront near Fenwick Pier

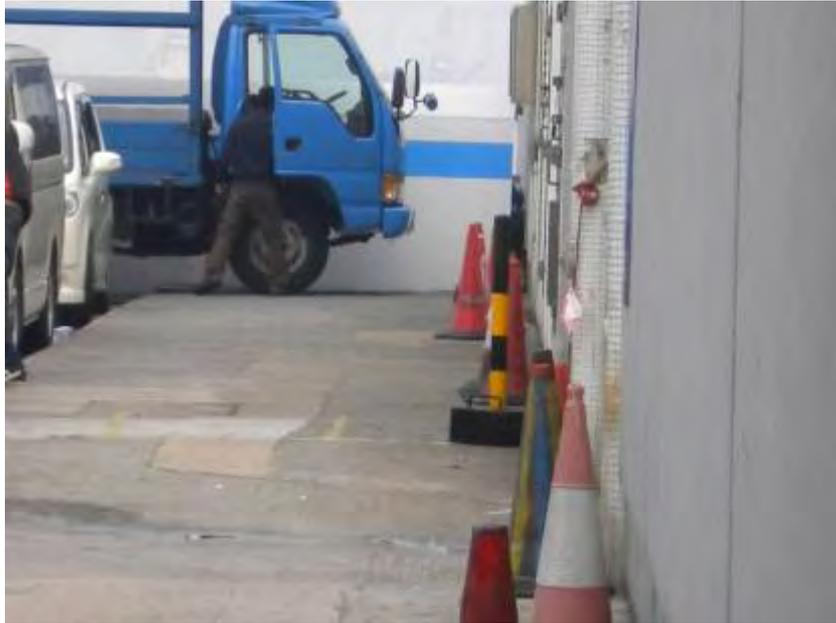
Figure 5.1-13 Breakdown at the End of Hill Road
