# Measurement and Analysis of Walkability in Hong Kong

An Interactive Qualifying Project Report  
Submitted to the faculty of the  
Worcester Polytechnic Institute  
In partial fulfillment of the requirements for  
Degree of Bachelor of Science  
In cooperation with Designing Kong Hong, Ltd. and  
The Harbour Business Forum  
On March 4, 2010

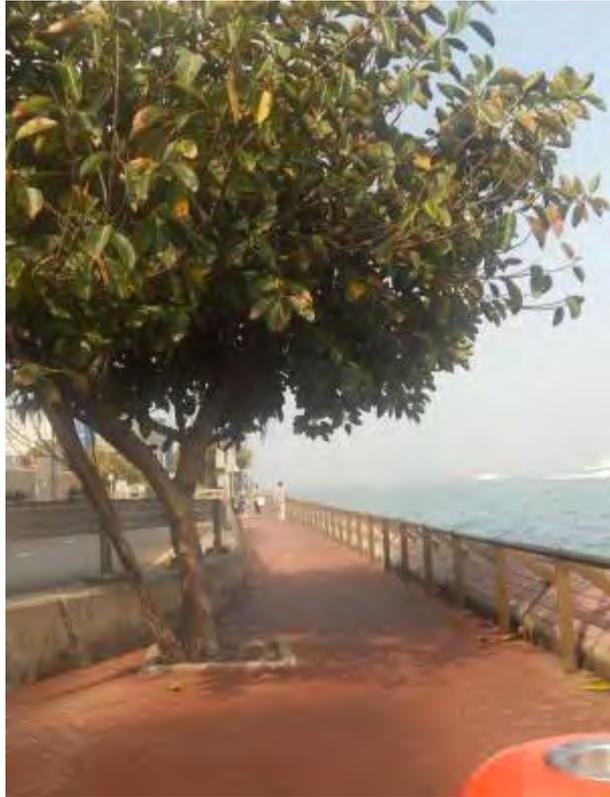
Figure 5.1-14 Existing Harbor Front at the End of Western Fire Services Street

Overall, the pedestrian experience can use improvements. To improve mobility around the area, a suggestion is to place a public transit stop at the intersection of Connaught Road West and Sutherland Street. This location will be convenient because there is a bus station at the beginning of the route and a MTR and Ferry Terminal to the east of the harbor front. This new location will provide another way of getting closer to the harbor but also will be conveniently located near Sun Yat Sin Memorial Park. To improve visual aesthetics along the route, small planters or greenery can be placed on the sidewalks. The streets are already overflowing with dried seafood shops and some color added to the streets will improve the aesthetics. There are a lot of small construction projects around which the safety and signage needs be checked. The signage for public transit stations and harbor front is lacking and installing signs at the intersections of roads will be very beneficial to the pedestrian. The seating areas along the route and harbor front promenade need to be increased. Figure 5.1-14 below shows the existing harbor front access with no seating areas. The harbor front promenade also needs to be built up more to include seating areas, greenery and a public toilet.

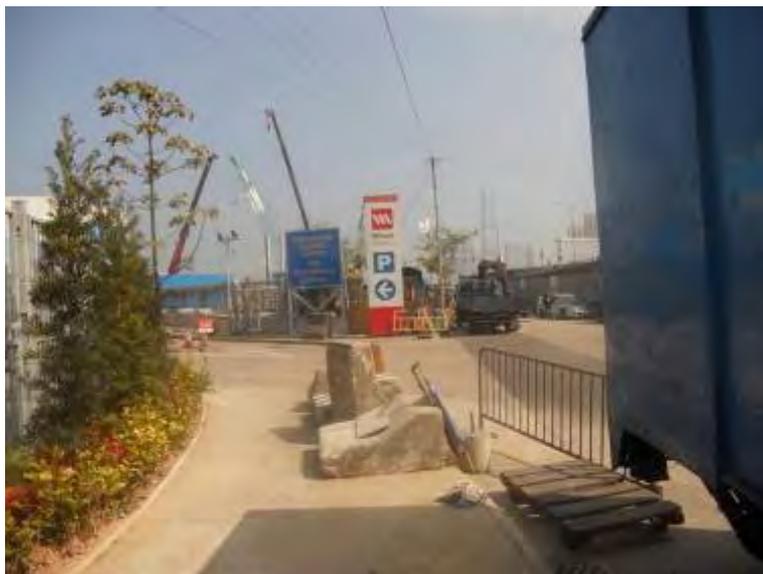
Figure 5.1-16 Breakdown at the End of Fung Mat Road

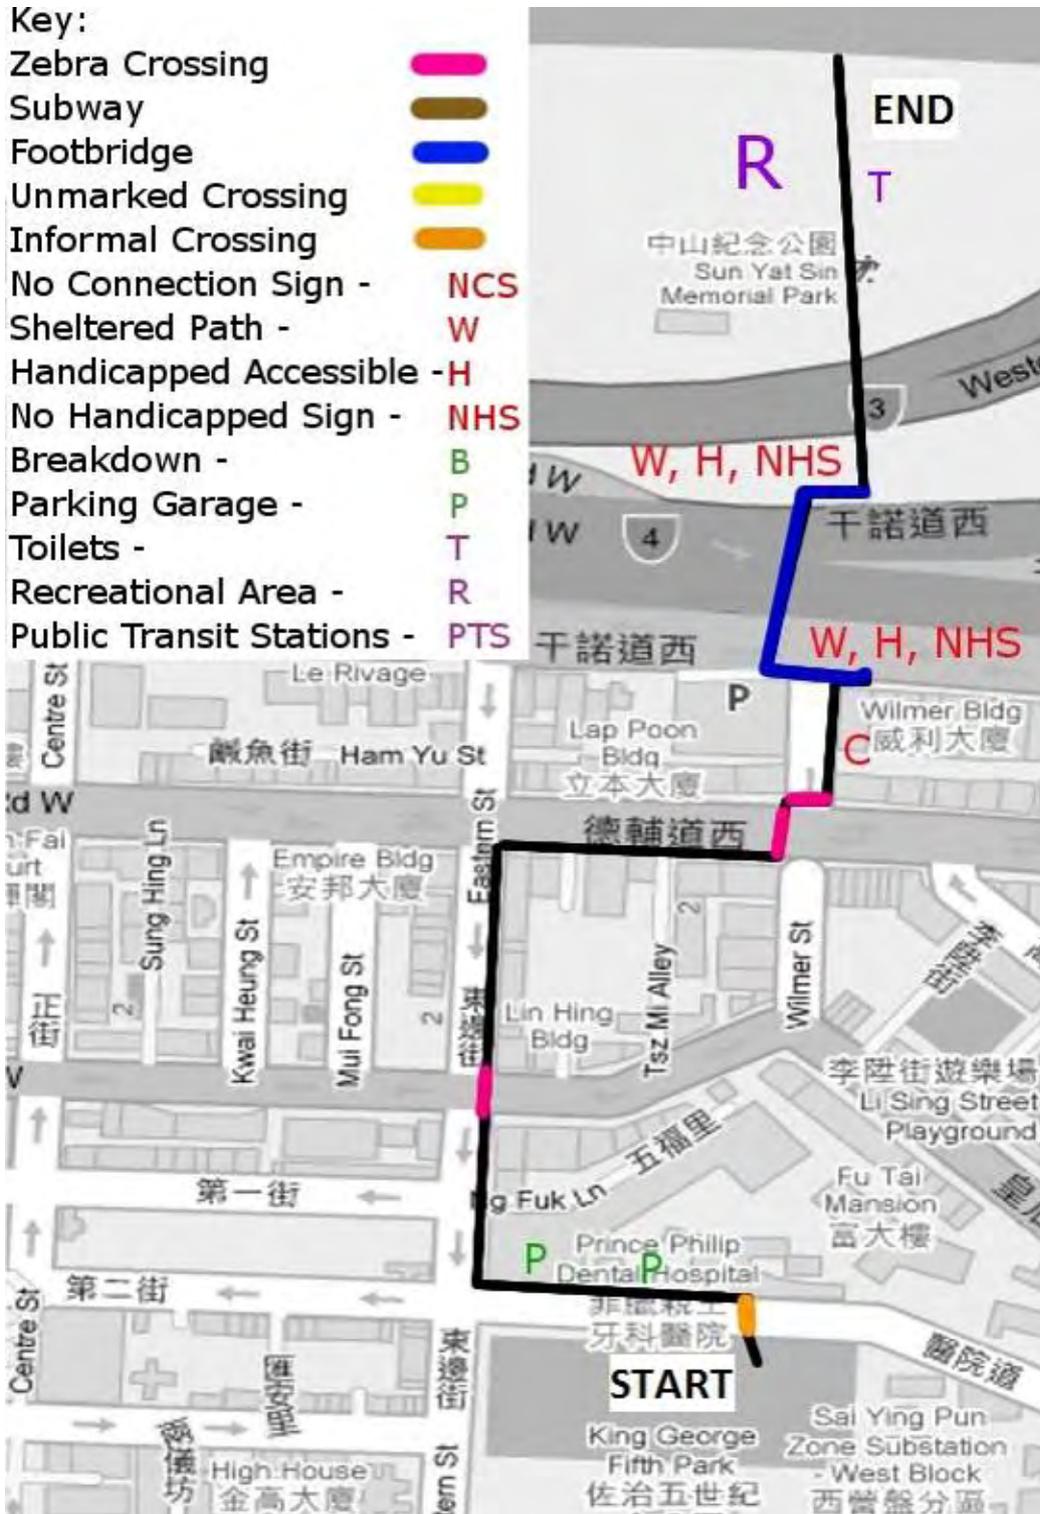
- Zebra Crossing █
- Subway █
- Footbridge █
- Unmarked Crossing █
- Informal Crossing █
- No Connection Sign - NCS
- Sheltered Path - W
- Handicapped Accessible - H
- No Handicapped Sign - NHS
- Breakdown - B
- Parking Garage - P
- Toilets - T
- Recreational Area - R
- Public Transit Stations - PTS
